Limited Visual Dam Safety Inspection Summary Report

MA-070

Reservoir 20

May 2006

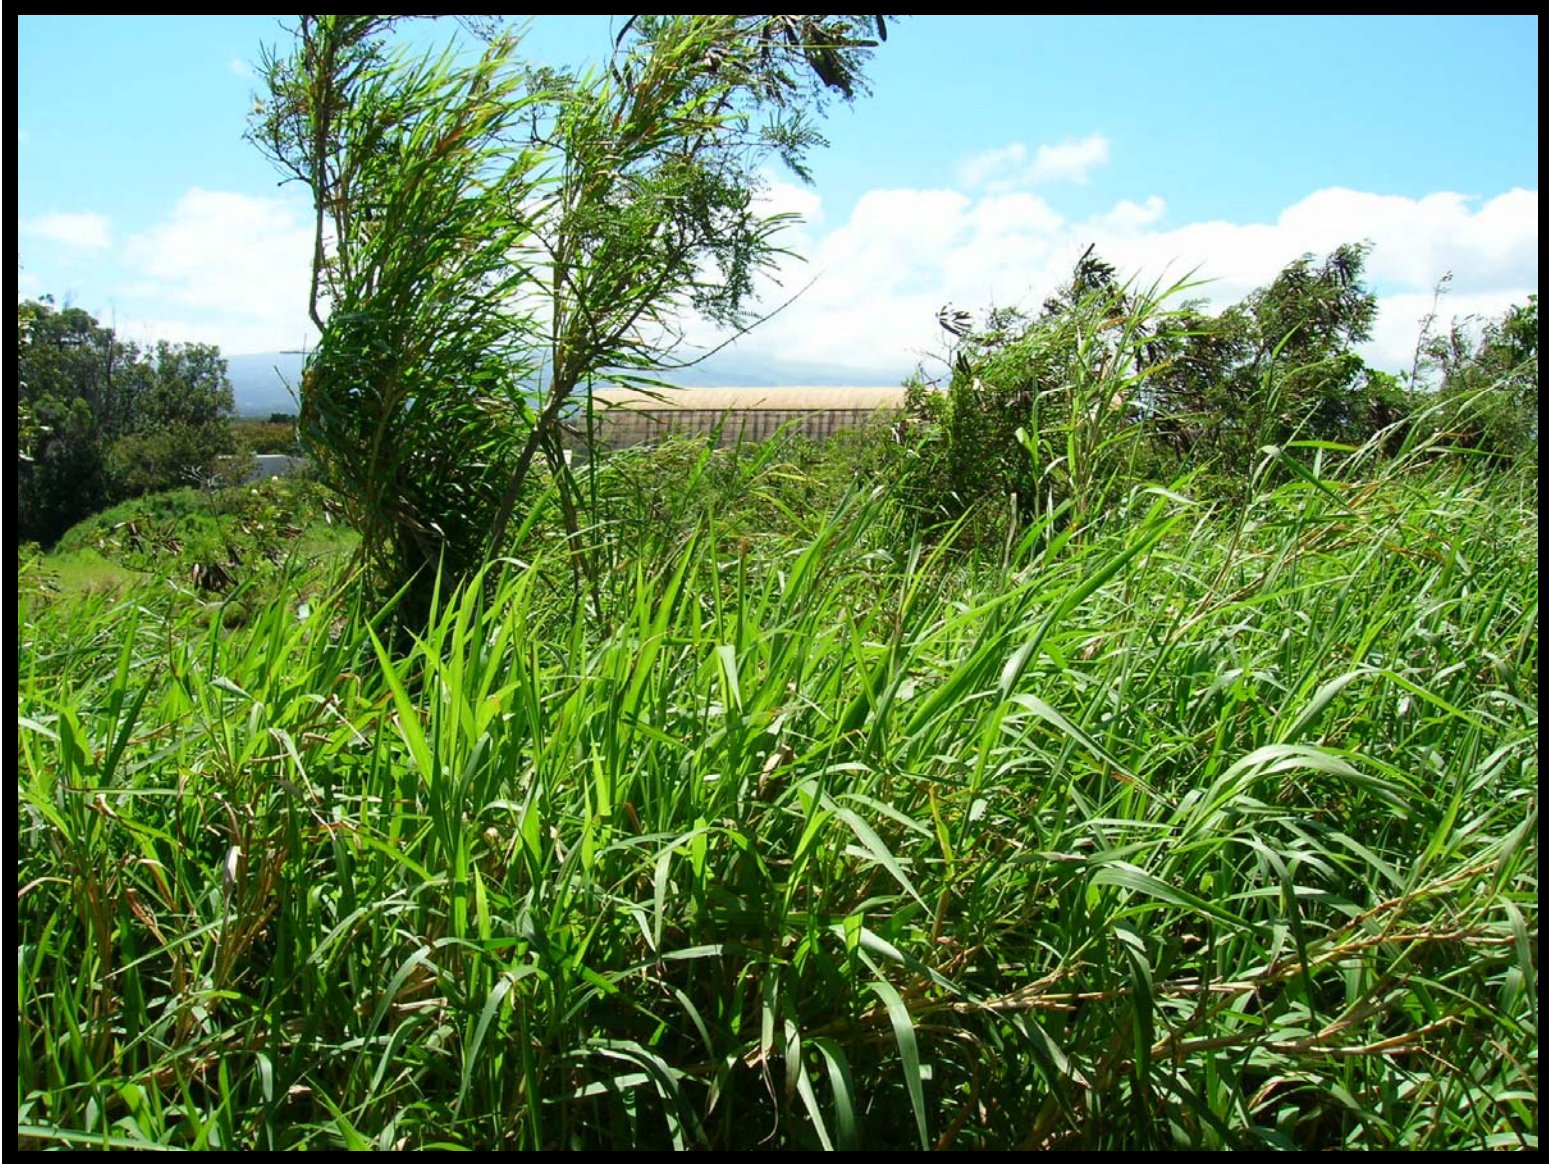
Sinkholes were not observed, however there were several low areas on the crest.

Several dips in crest up to 3' in depth – dips vary in size. Unsure of cause of dips.

070 crest

- a. The dam crest appeared to be in fair to poor condition and requires corrective action.
- b. Dips were observed on the crest, which requires further investigation to determine the underlining cause. Repair and monitor the area. Fill low areas to establish consistent crest elevation.

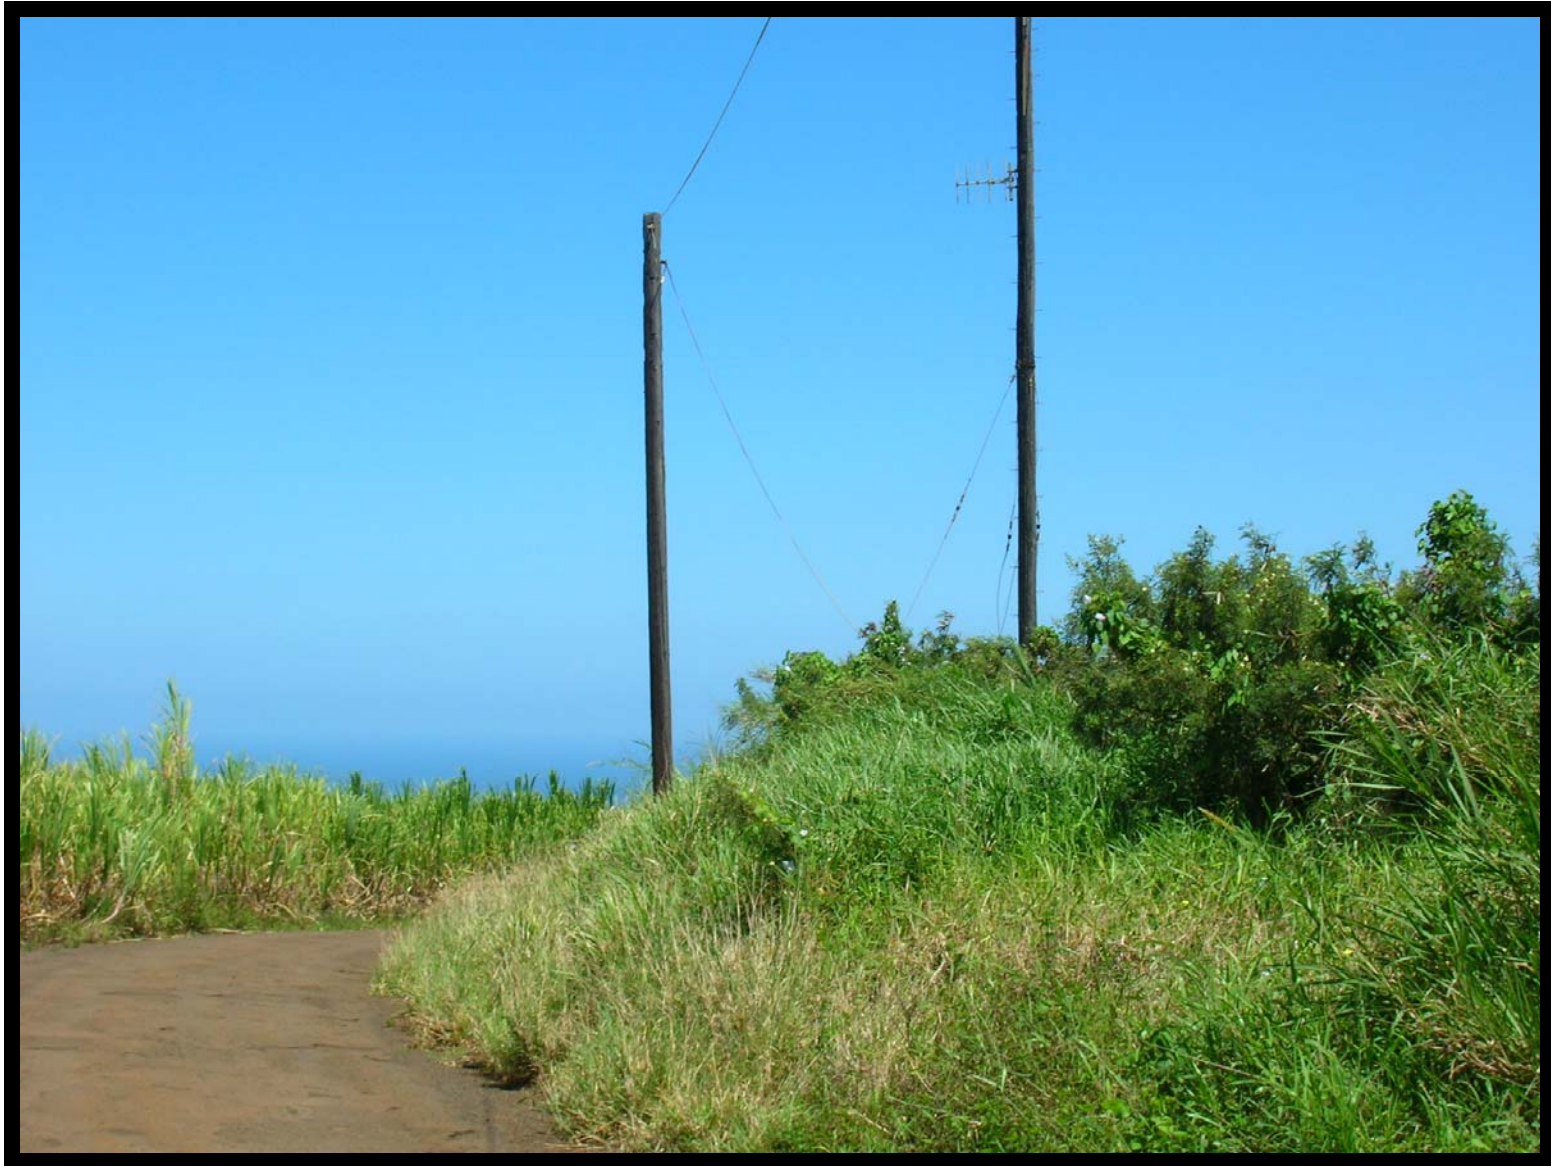
- d. Tree(s) were observed on the downstream slope. Trees have been identified as the probably cause of piping failures, and can possibly cause sever damage to the embankment if they are uprooted during a high winds. Corrective action is required to remove the tree hazards from the dam. Acceptable remedies include removal of the tree and its root structure down to a 2" diameter and reconstructing the damaged embankment section. All repair work shall be accomplished as per the requirements of licensed geotechnical or structural engineer. Routinely monitor the damaged area for signs of settlement and seepage.
- e. The slope was very steep, around a 1 to 1 slope; further study is required to verify slope stability.
- f. Utility poles at toe – potential piping path.

070 downstream slope – poles in embankment

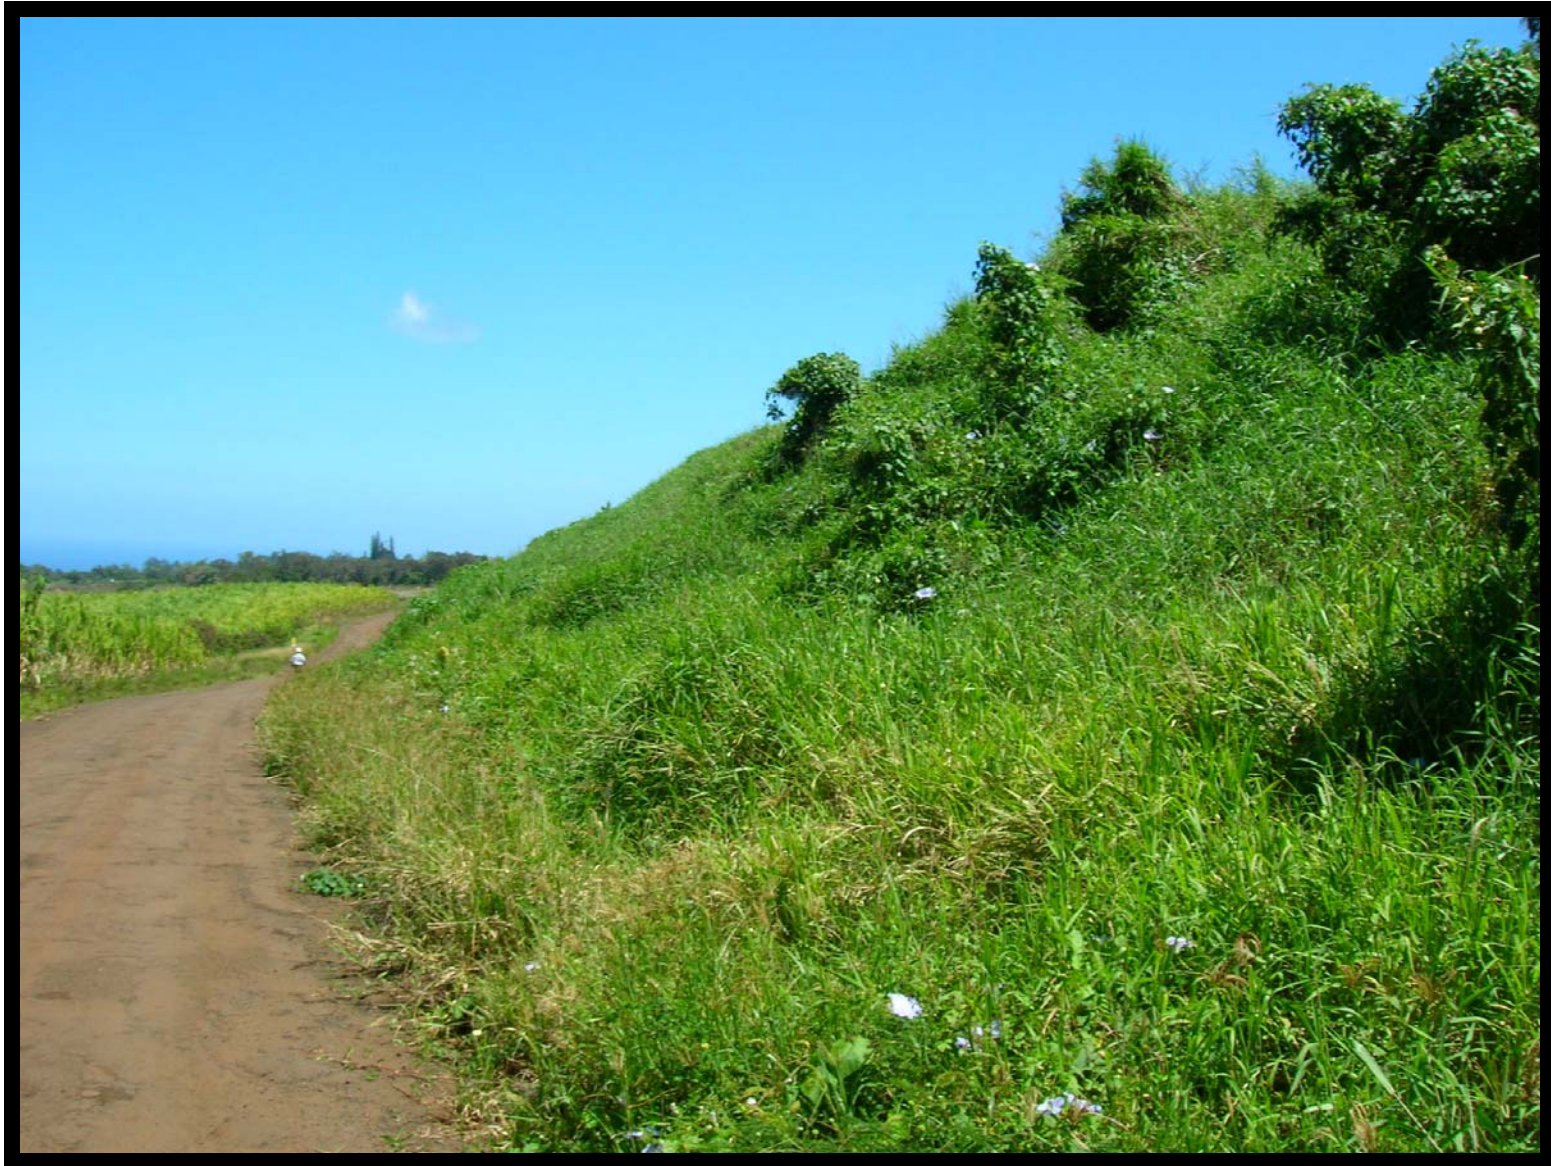
070 downstream slope 2

The downstream slope was in fair to poor condition and not visible due to heavy vegetation. The slope was very steep, around a 1 to 1 slope.

Vegetation was observed on the downstream slope. The majority of the vegetation was woody trees ranging from 2" to 2 feet in diameter.

- a. The downstream slope appeared to be in fair to poor condition and requires corrective action.
- b. Gully erosion was observed on the slope, which requires maintenance and repair. Repair scarps.
- c. The down stream slope was not visible due to high grass and bush vegetation. Clear high vegetation and maintain low to enable easy visual inspection.

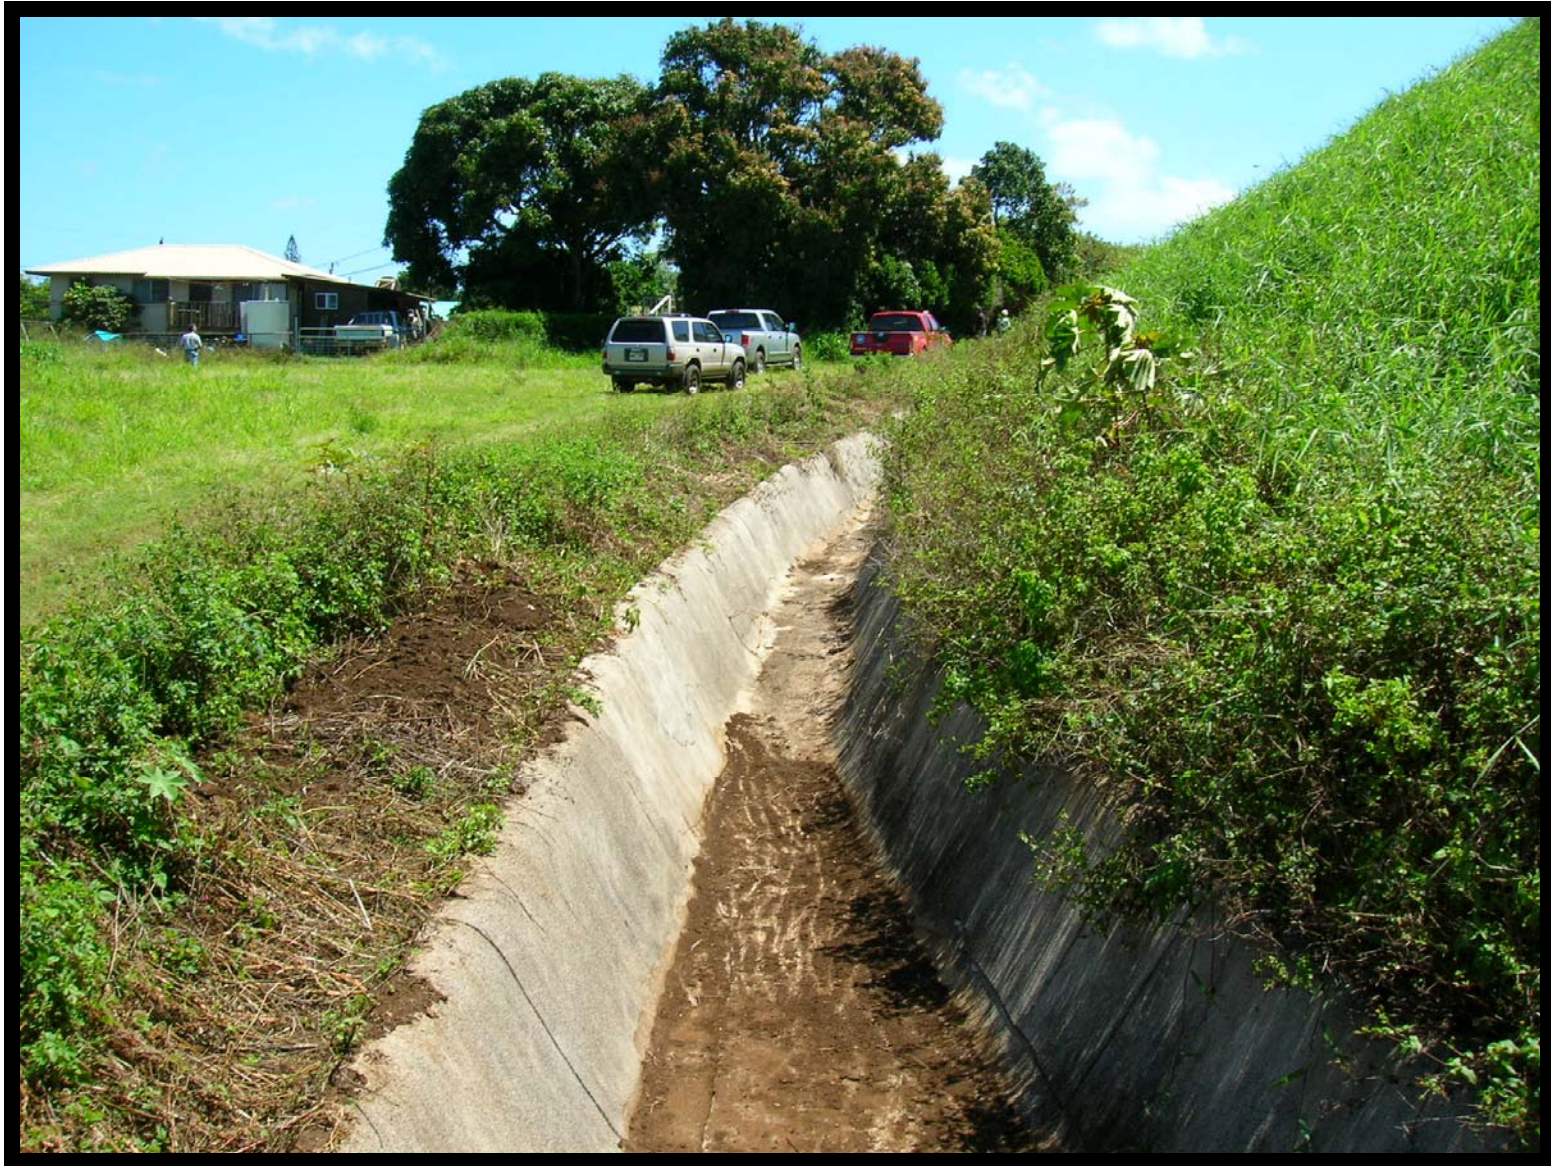
070 downstream slope 4 – concrete spillway ditch

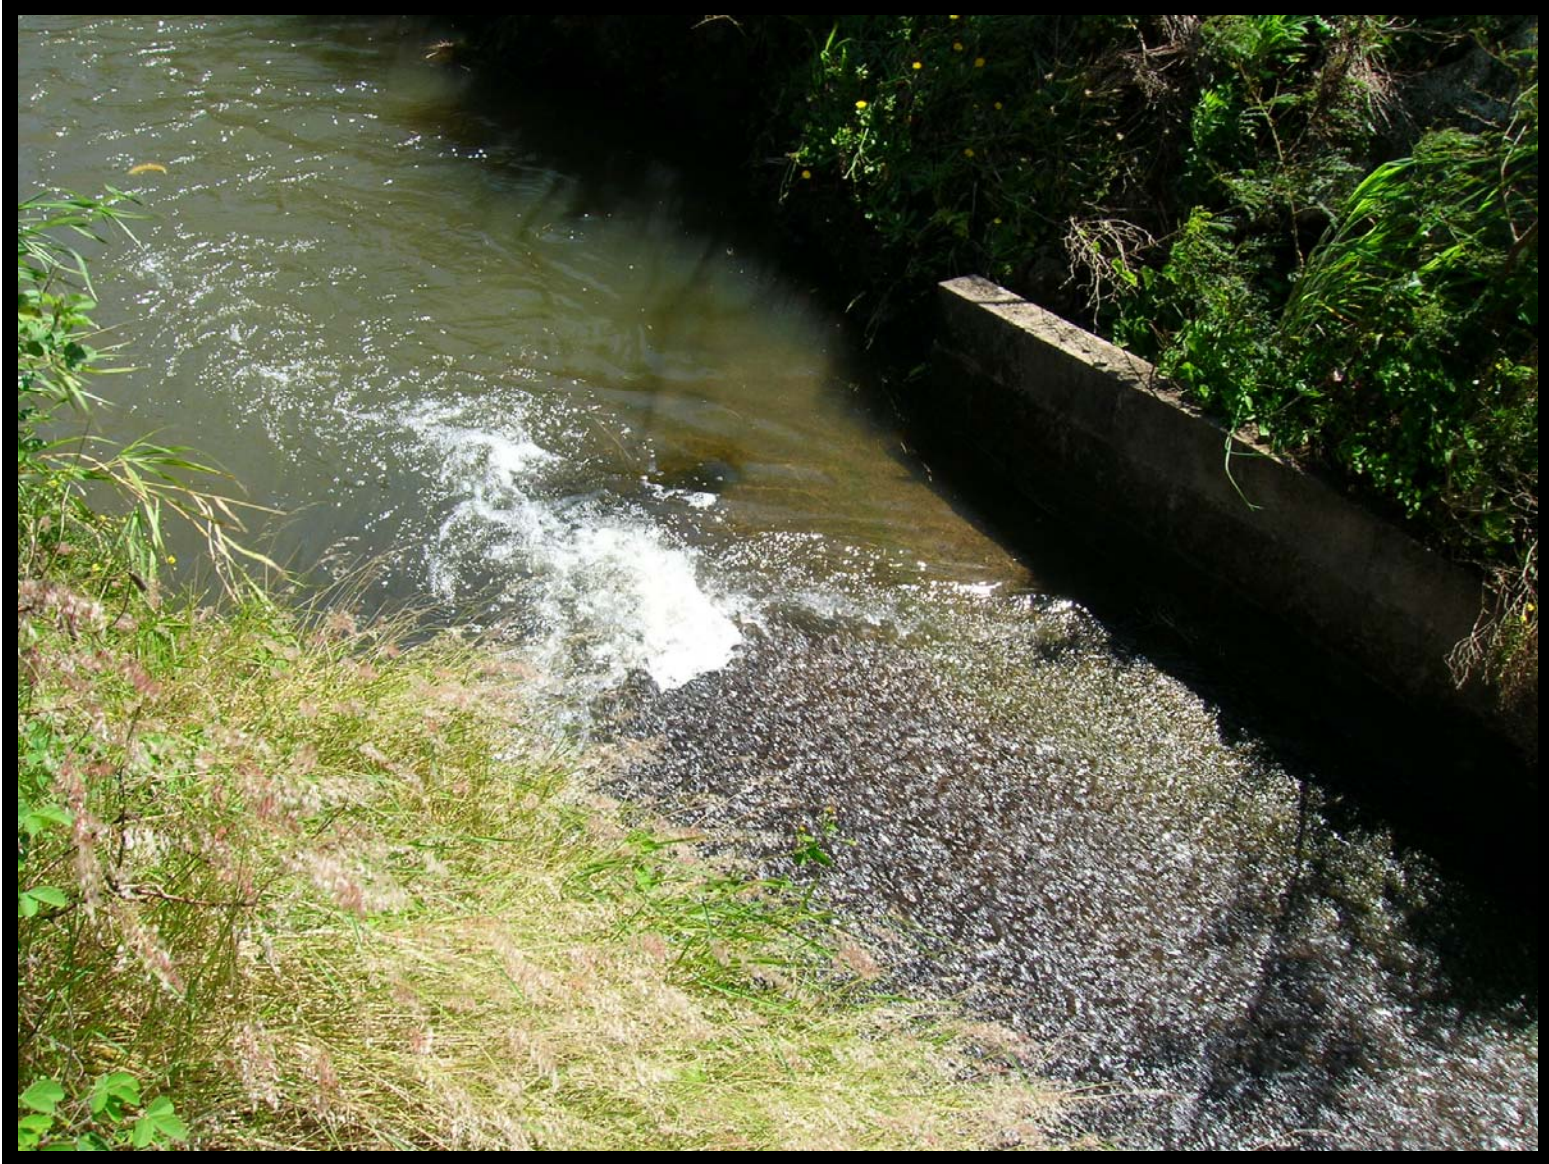
070 inlet

- a. The intake works were not tested.
- b. The intake works appeared to be in satisfactory condition, no corrective actions are required at this time.

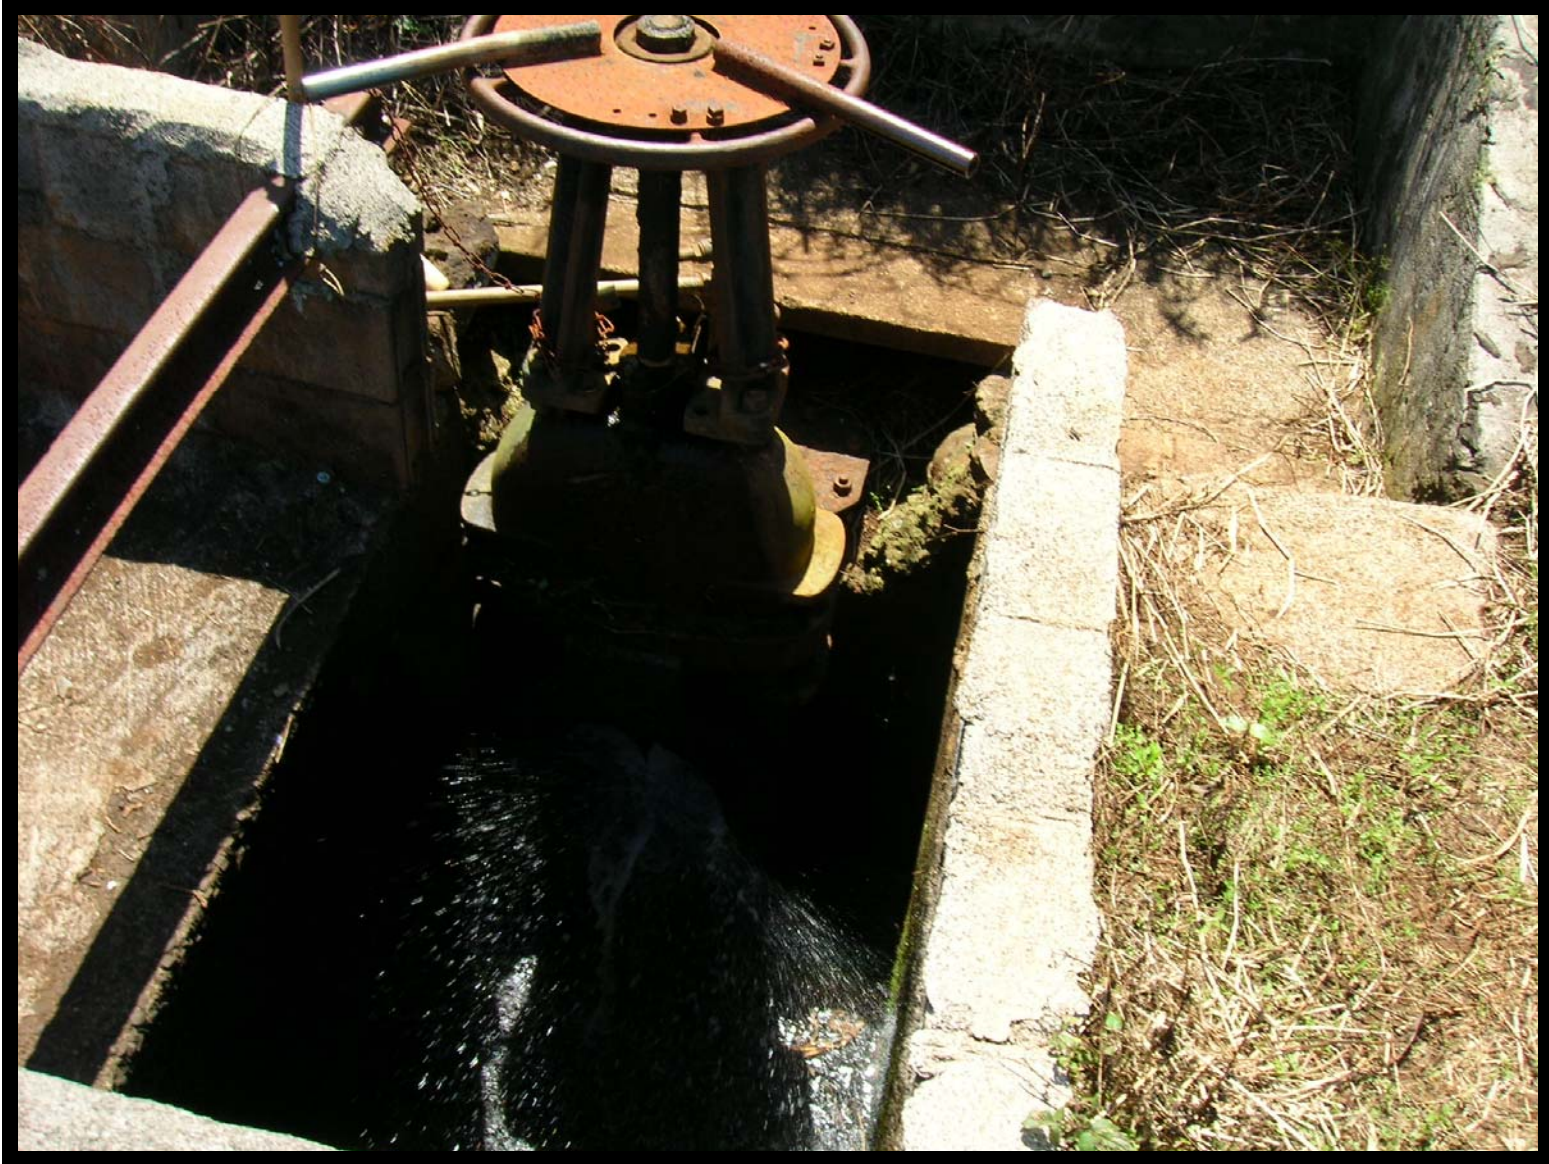
070 outlet

- a. The outlet works were not tested.
- b. The outlet works appeared to be in satisfactory condition, no corrective actions are required at this time.

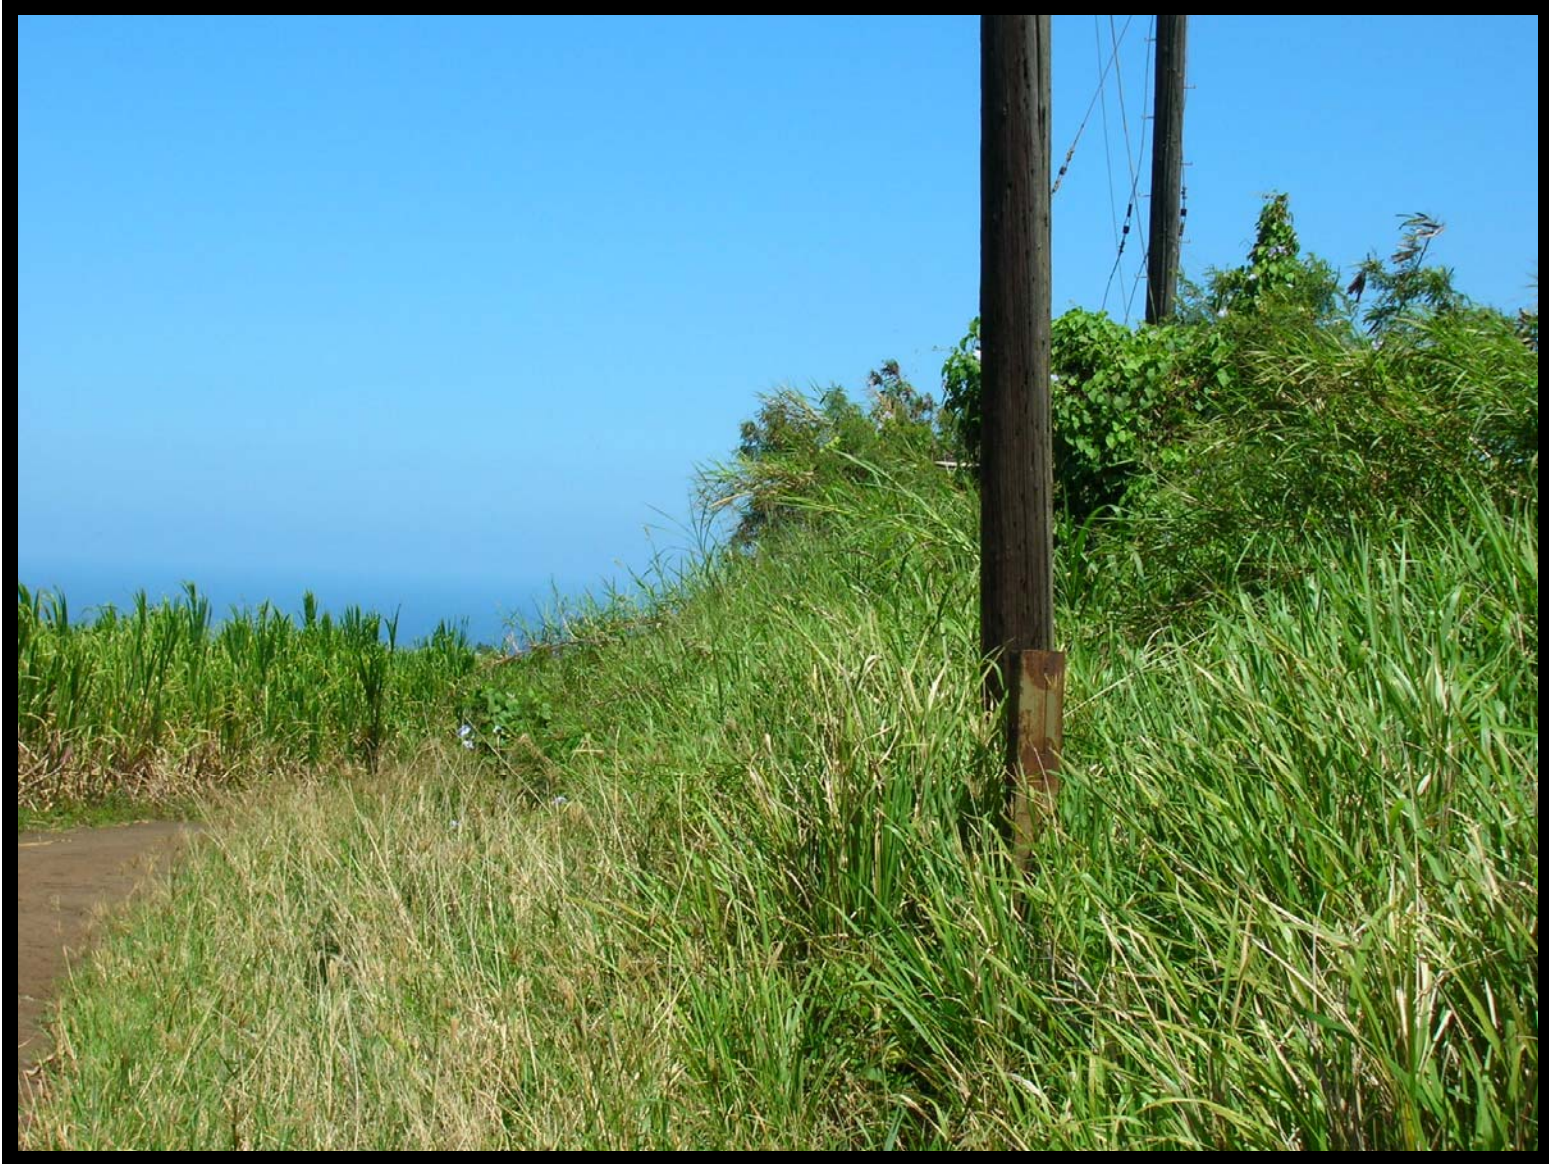
070 poles in slope

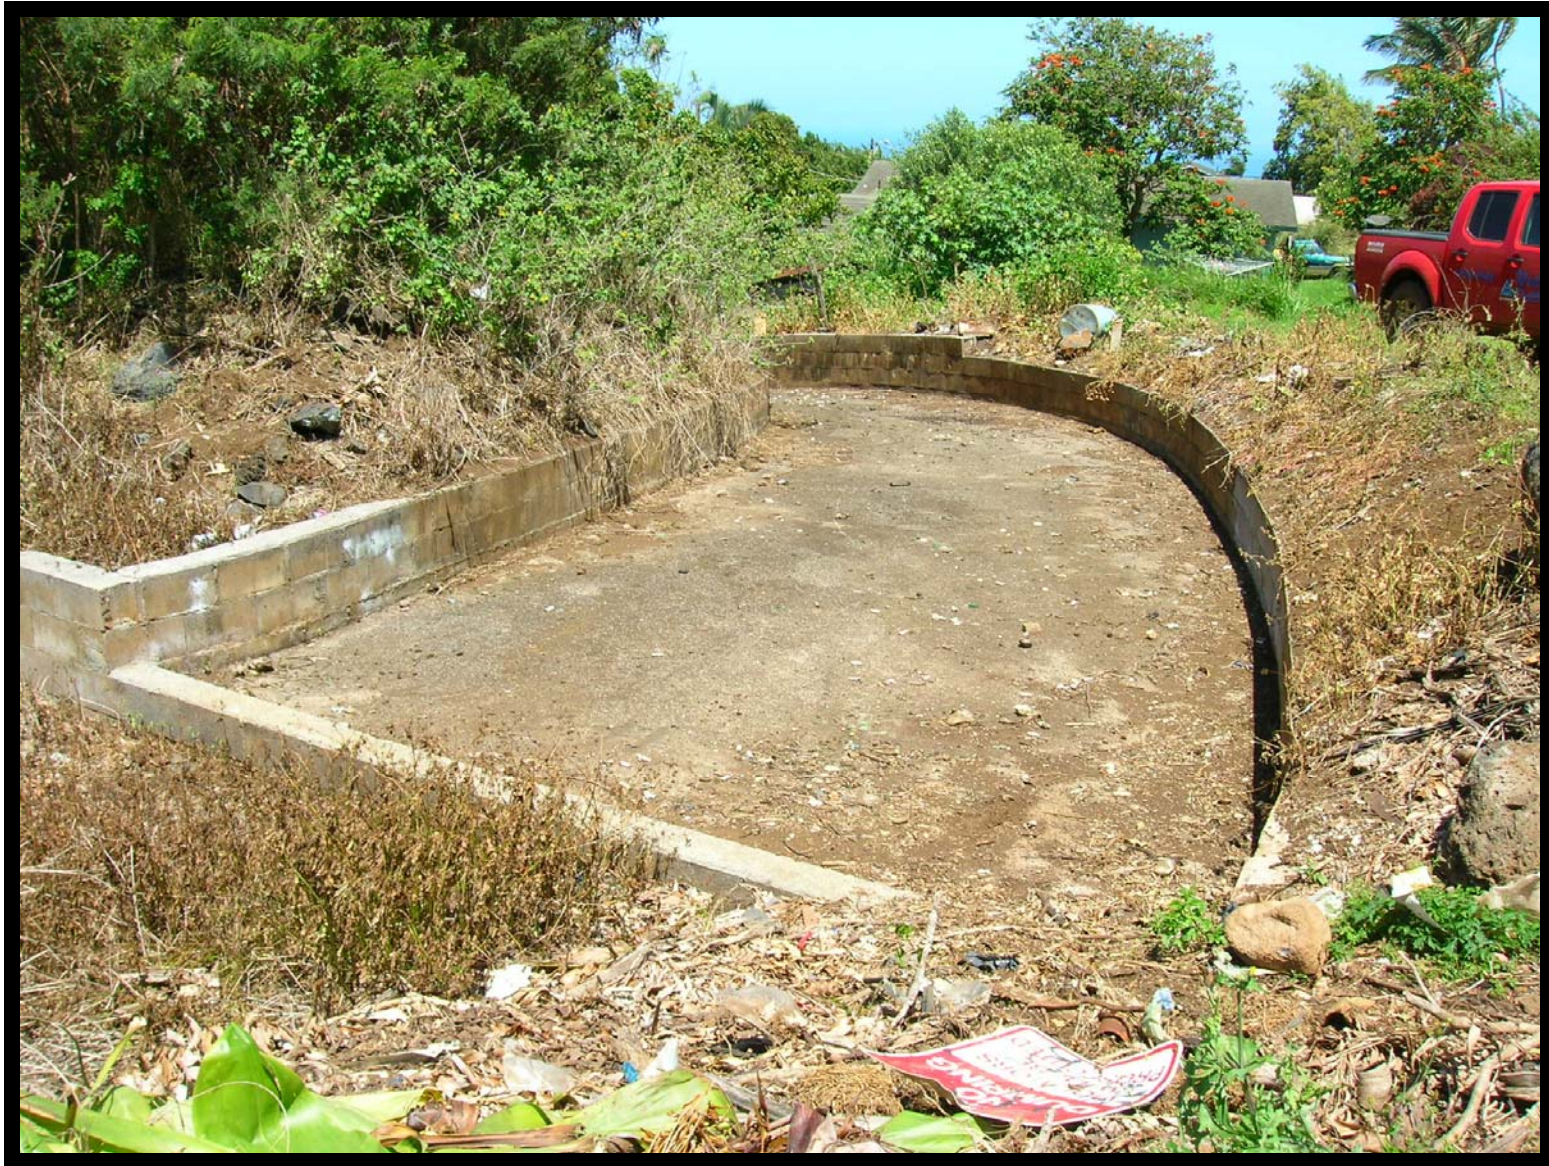
070 spillway

- a. The spillway appeared to be in fair to poor condition and requires corrective action.
- b. Unclear if spillway is adequately sized. Spillway should pass the probable maximum flood. Verify spillway capacity and take corrective action as required.

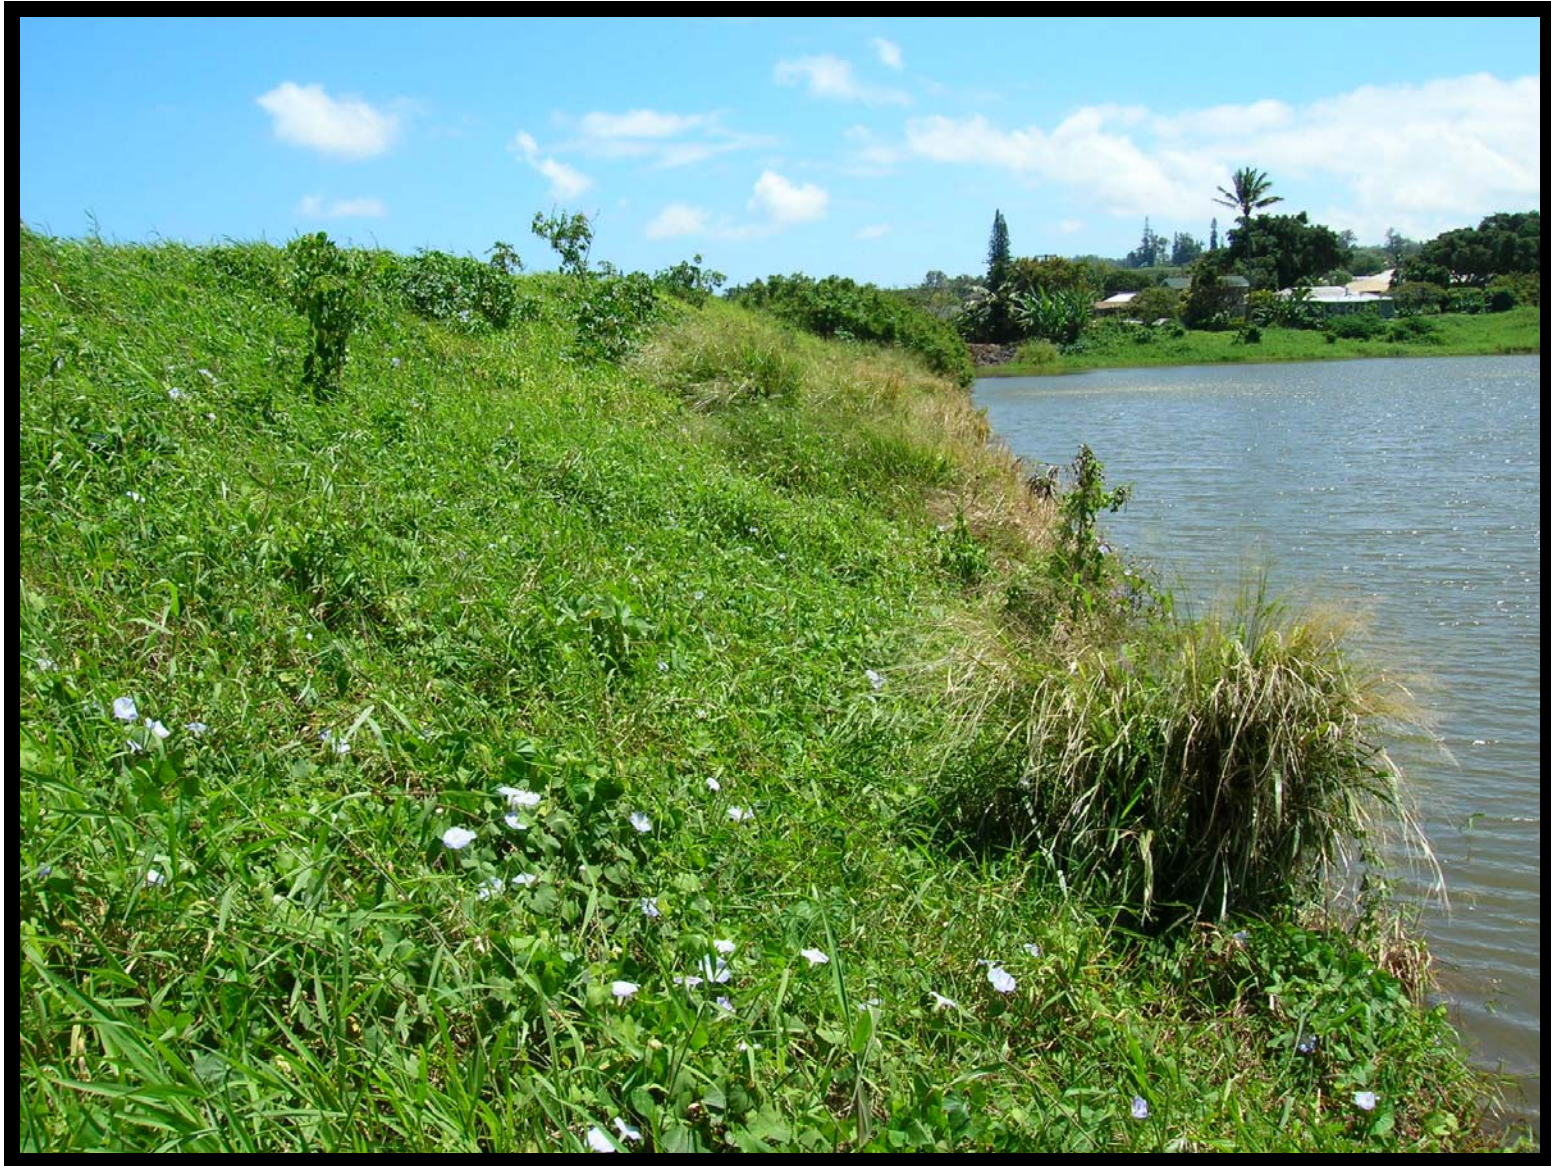
070 upstream slope

The upstream slope varied in slope and ranged from a 2H to 1V (Horizontal/Vertical). A partial rip rap slope protection was observed. Erosions were not visible; the slope was not entirely visible.

Cracks were not visible; the slope was not entirely visible.

- a. The upstream slope appeared to be in fair to poor condition and requires corrective action.
- b. The upstream slope was not visible due to high grass and vegetation. Clear high vegetation and maintain low to enable easy visual inspection.
- c. Tree(s) were observed on the dam embankment. Trees have been identified as the probably cause of piping failures, and can possibly cause severe damage to the embankment if they are uprooted during high winds. Corrective action is required to remove the tree hazards from the dam. Acceptable remedies include removal of the tree and its root structure down to a 2" diameter and reconstructing the damaged embankment section. All repair work shall be accomplished as per the requirements of licensed geotechnical or structural engineer. Routinely monitor the damaged area for signs of settlement and seepage.
